Automotive Manufacturing Stamping

Depth Filtration Causes Production of Defective Units

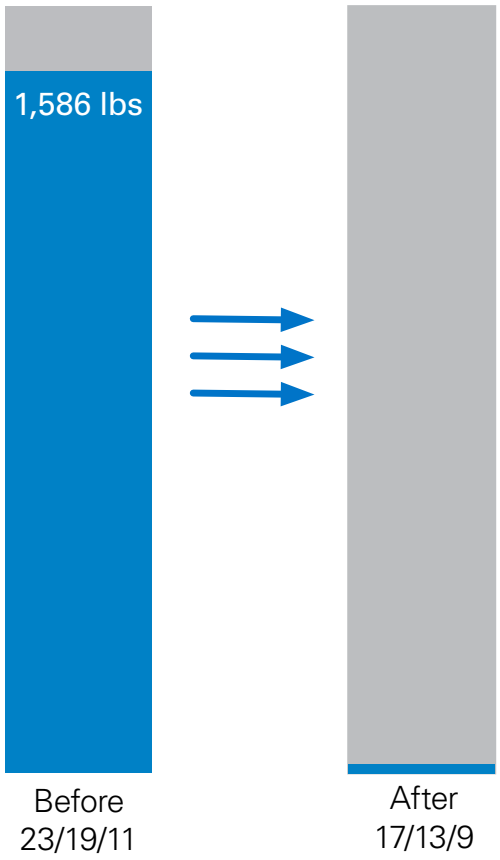
Amount of Dirt Passing Through Components per Year

The uncoiler / washer lube oil system was protected by an off-line filtration system fitted with CJC stacked disc cellulose media filter inserts (elements). Oil analysis revealed an operating ISO code of 23/19/11. Patch analysis showed cellulose fibers were shedding into the oil from the filter inserts downstream of the filtration system.

To verify the results the stamping plant put another set of the original CJC filters back in the off-line filter system and within 15 days the operating ISO code was 23/19/11 again.
